3-YEAR ASBESTOS RE-INSPECTION REPORT

CHARLES SUMNER ELEMENTARY SCHOOL SCRANTON, PA

**SCRANTON SCHOOL DISTRICT
425 North Washington Avenue
Scranton, Pa. 18505**

PROJECT: #SSD.19_751

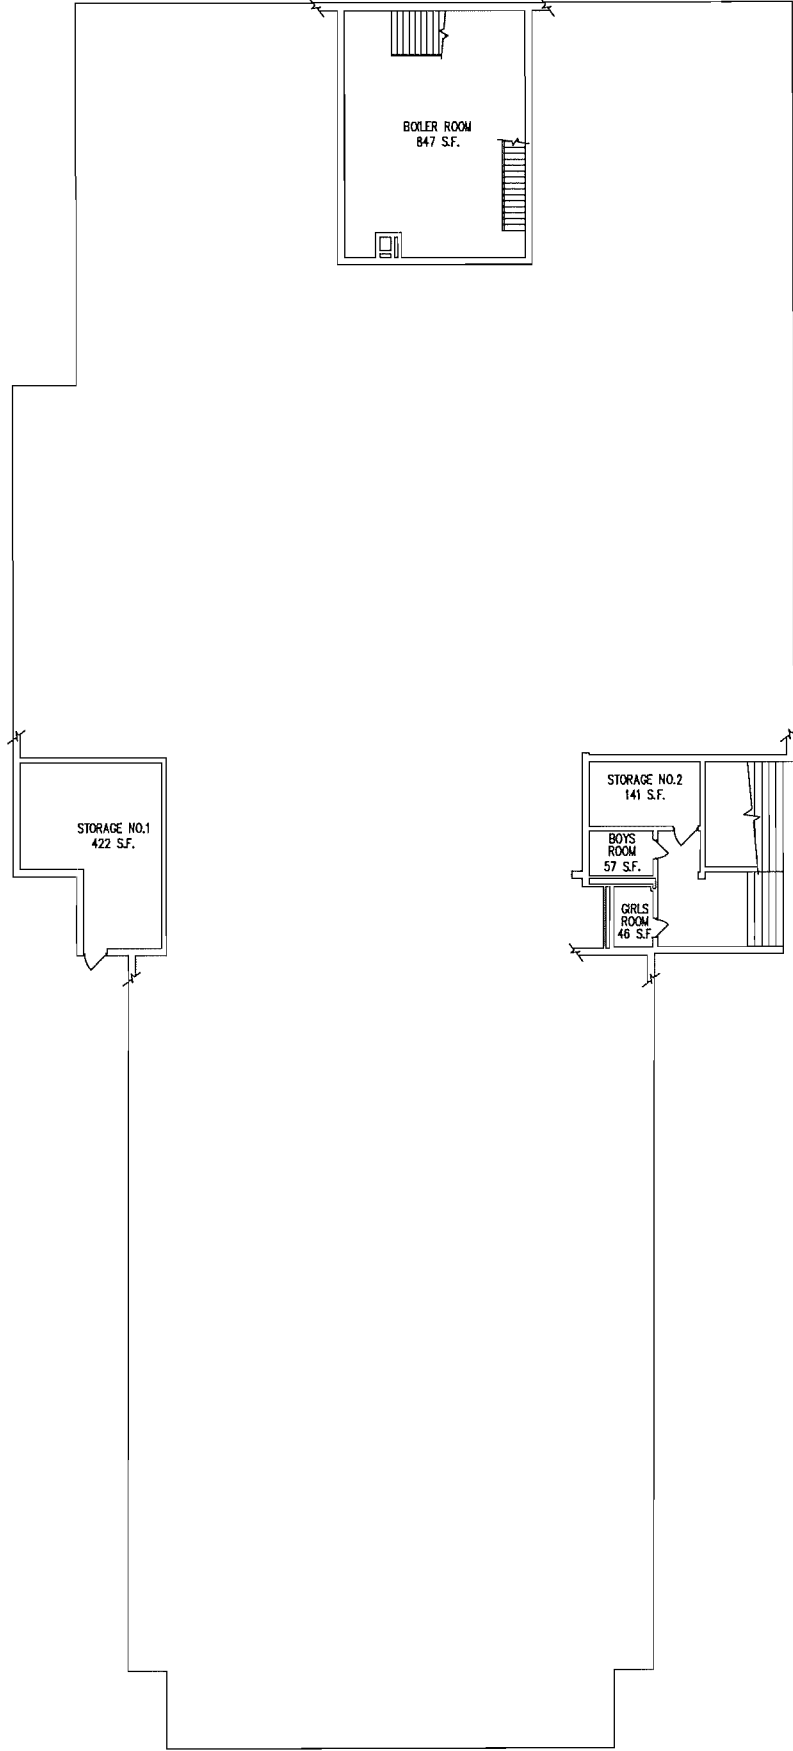
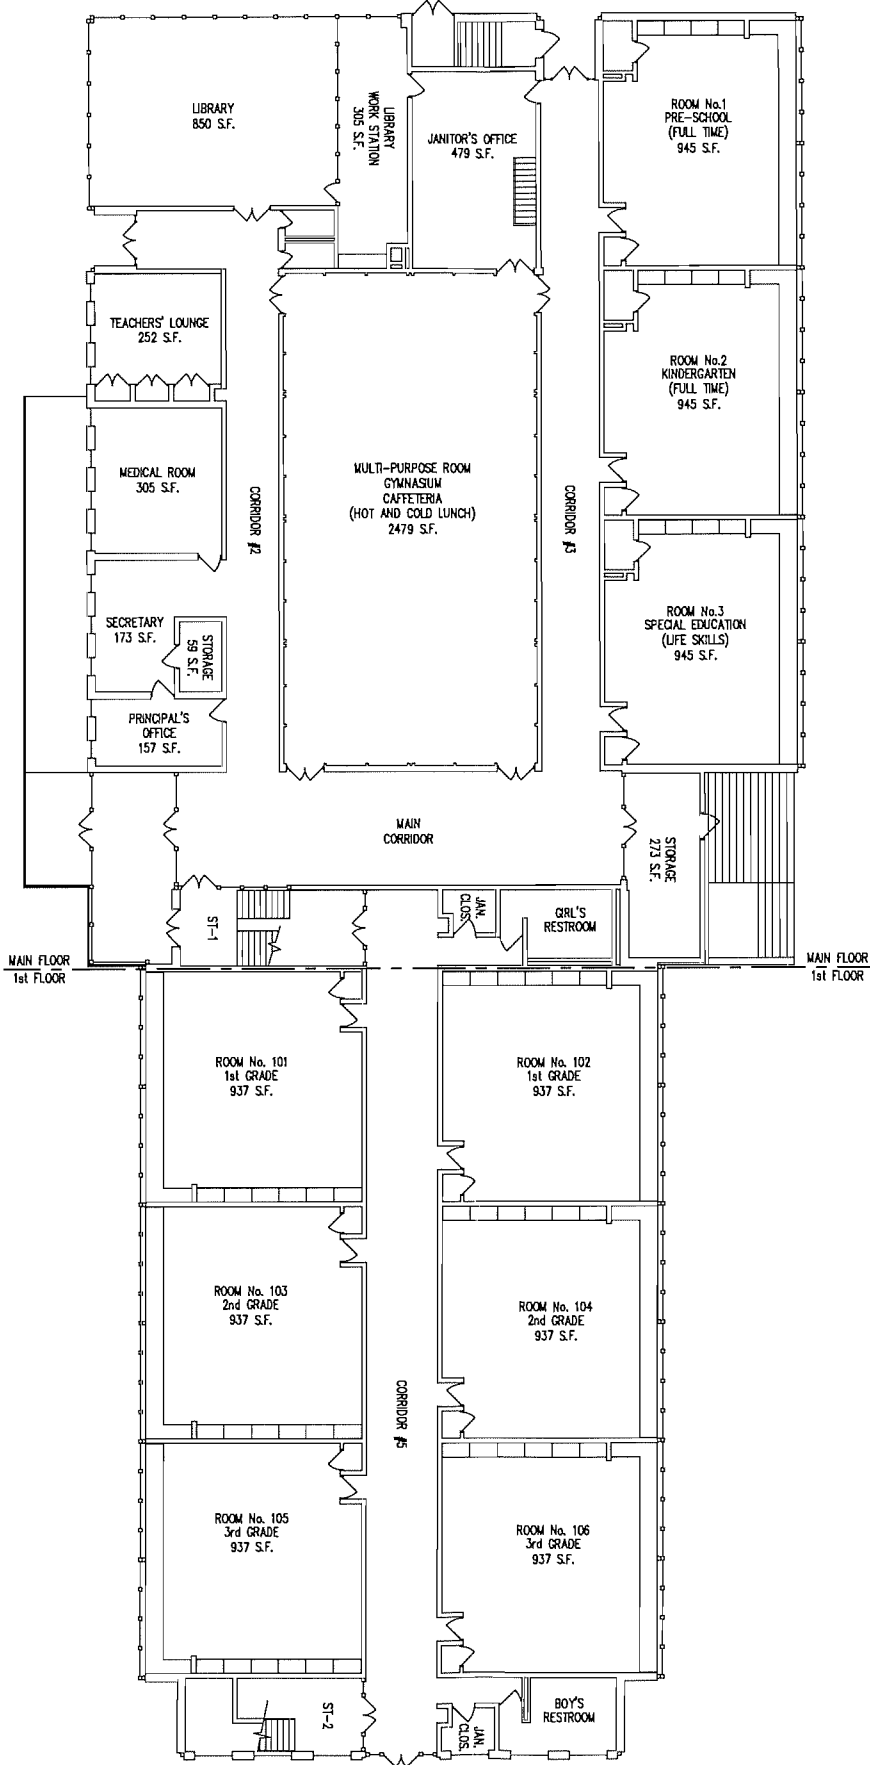
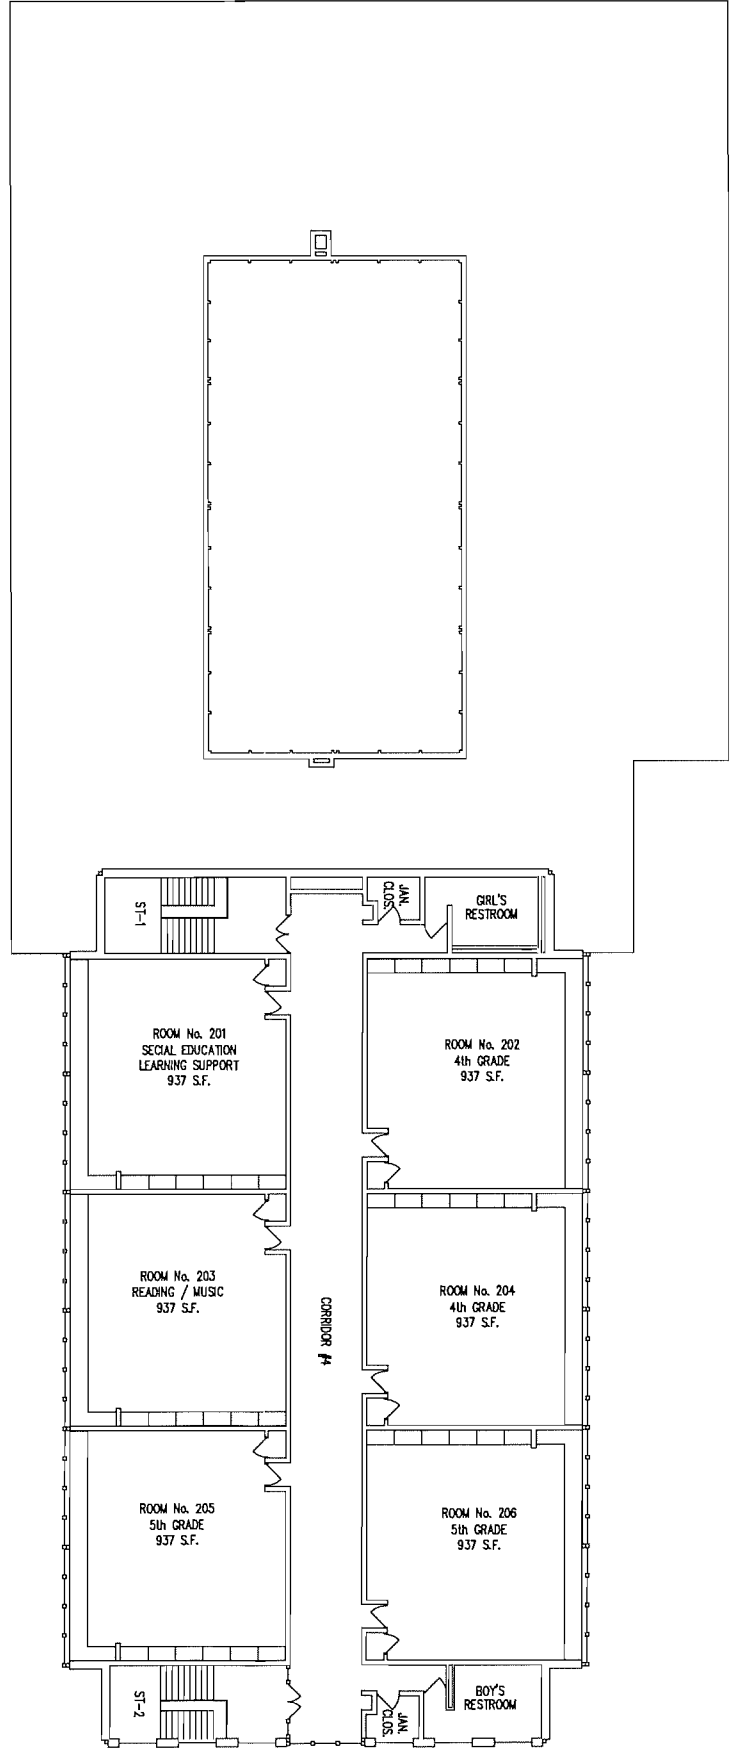
DRAWING No.:
A
1

KEY - SURFACING ACM
ASSUMED ASBESTOS CONTAINING
SURFACING MATERIALS ON ALL FLOORS:
1. EXTERIOR COATING ON SINKS

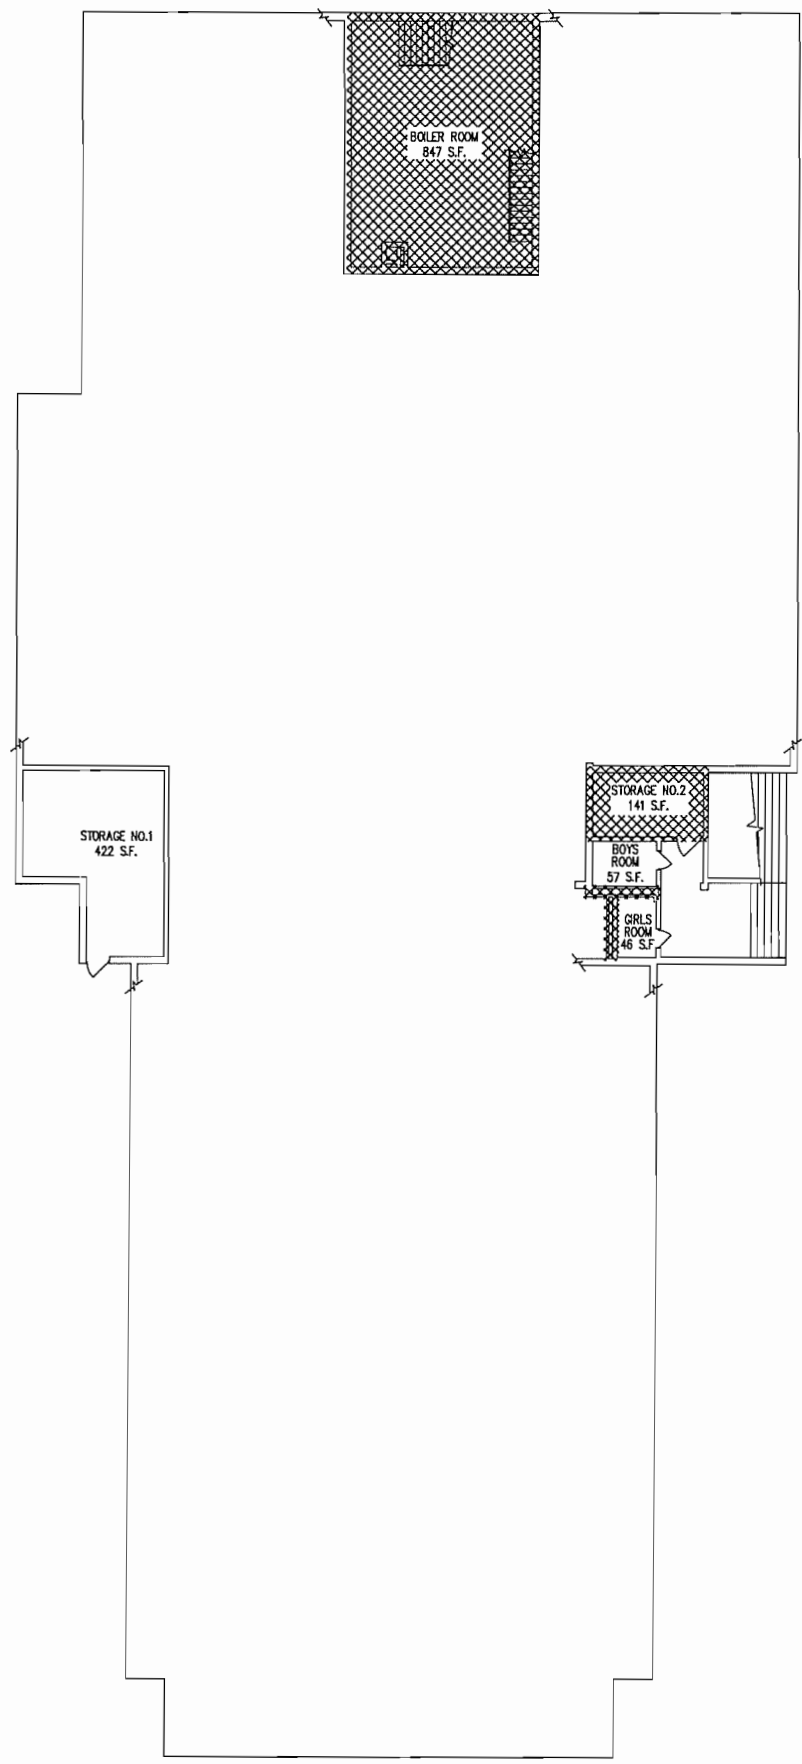
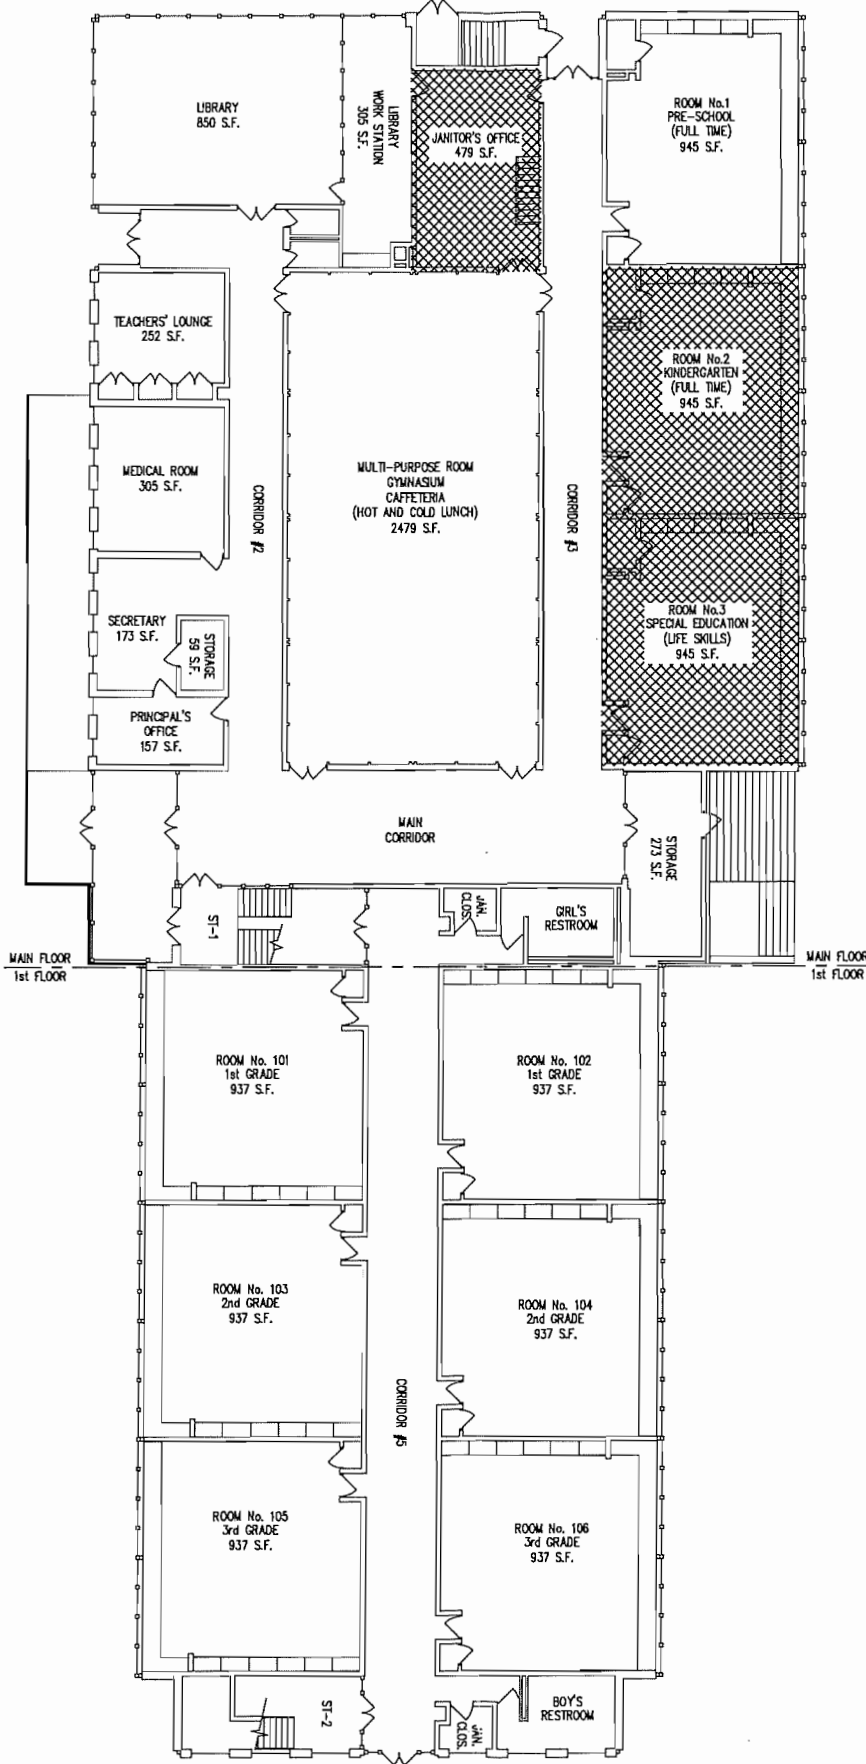
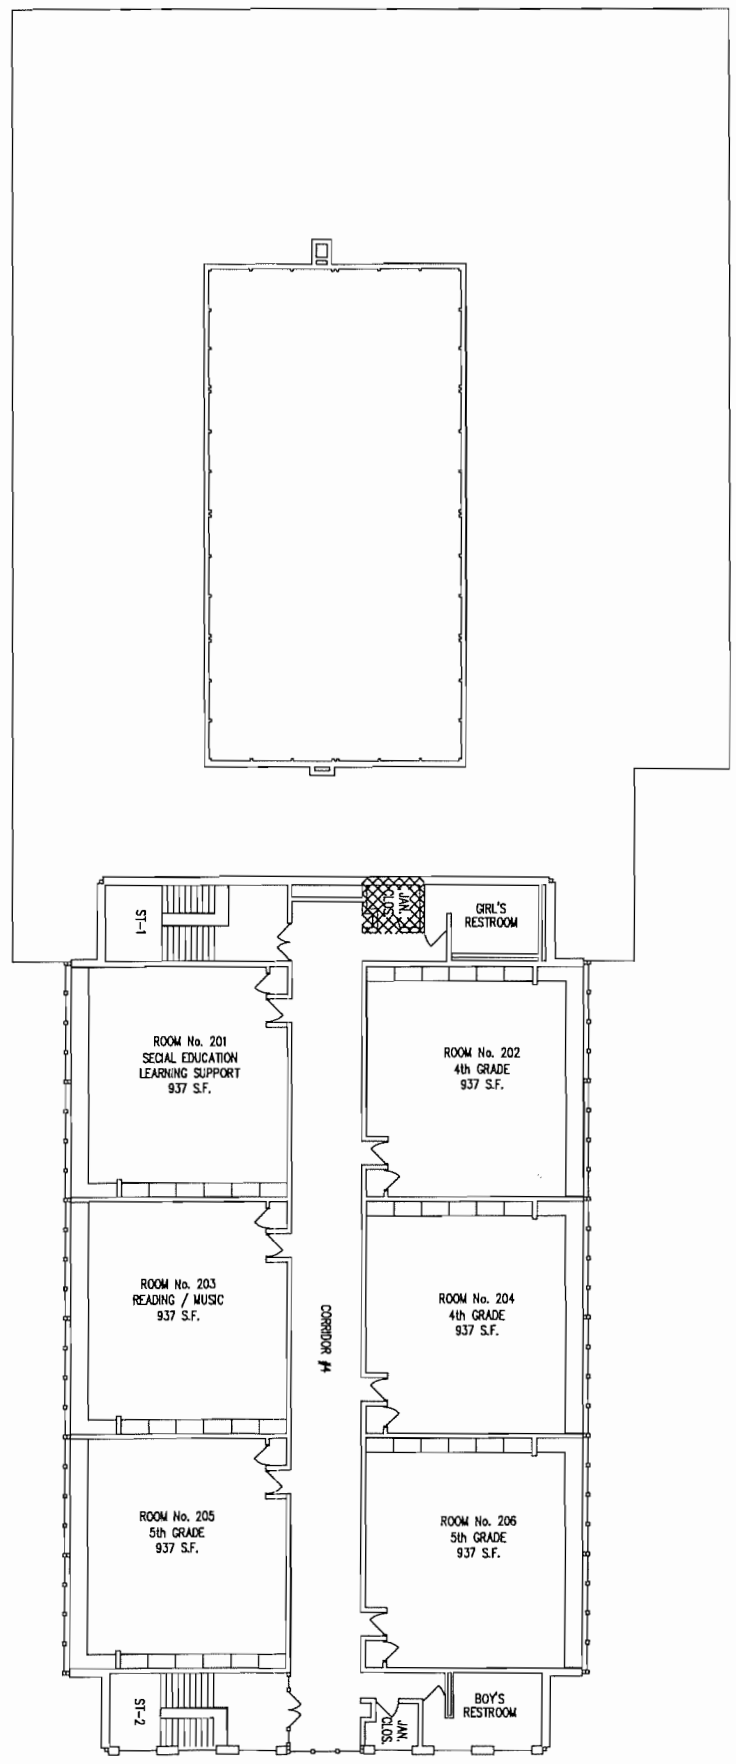
DRAWING No.:
A
2

THERMAL ASBESTOS CONTAINING MATERIALS

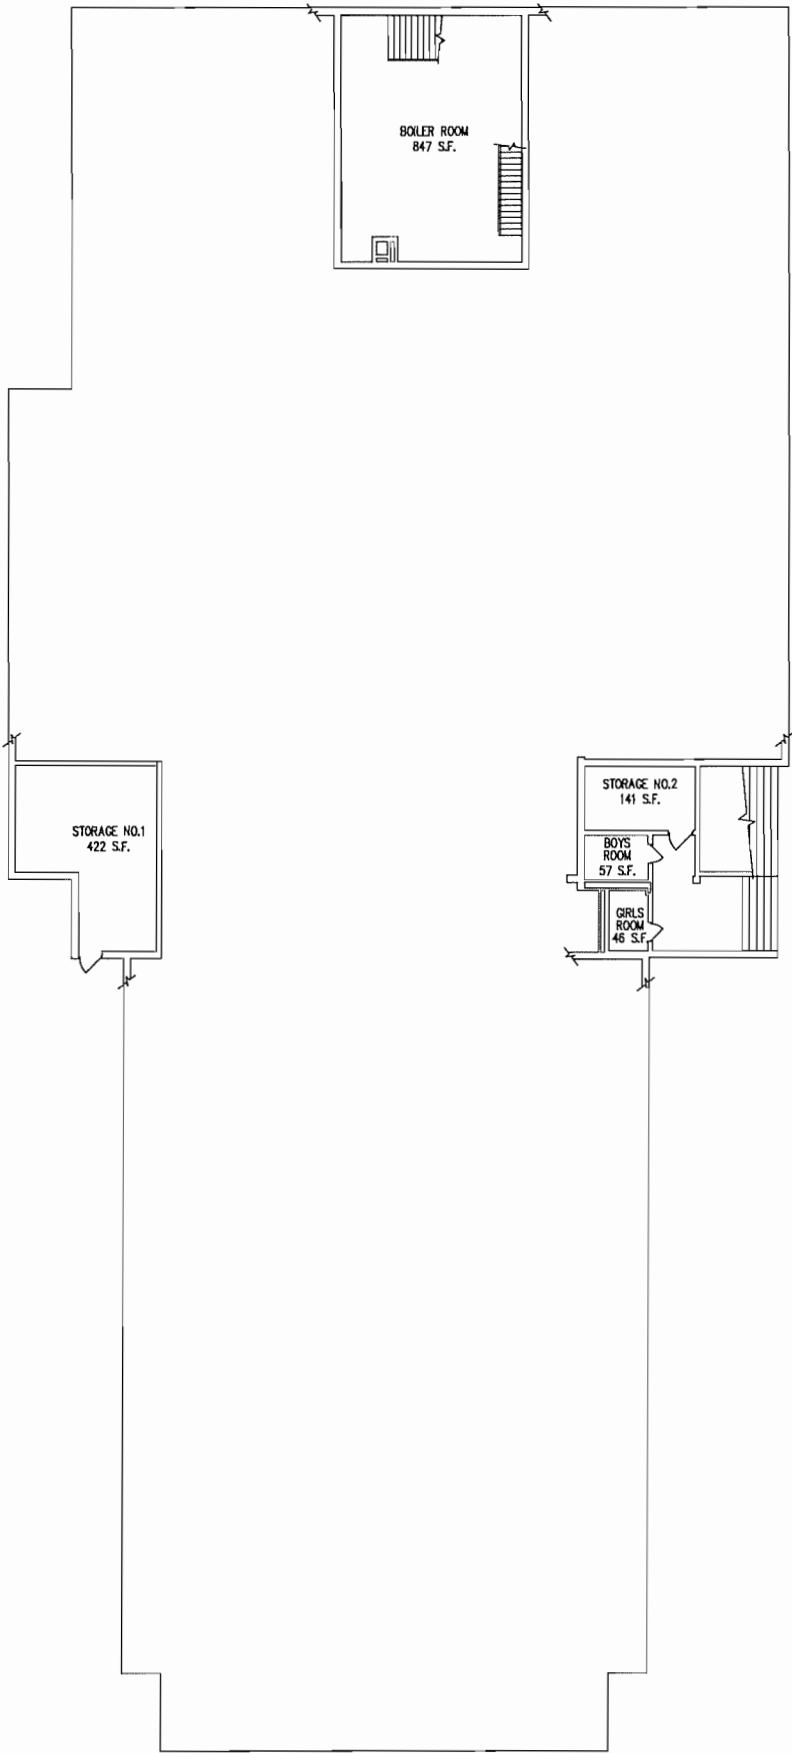
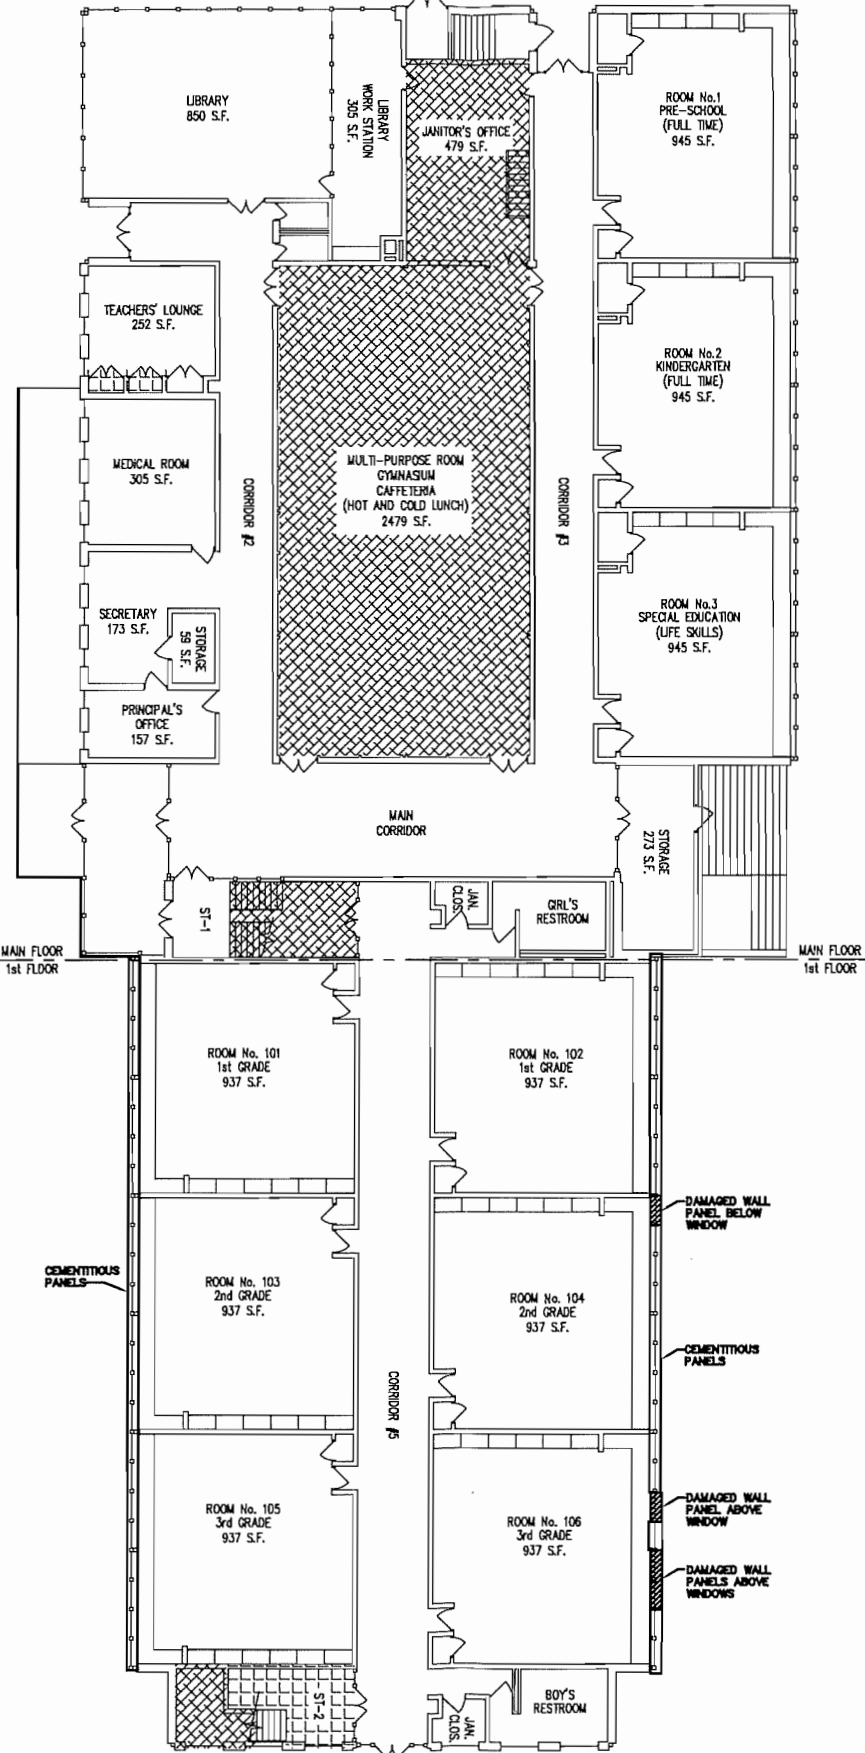
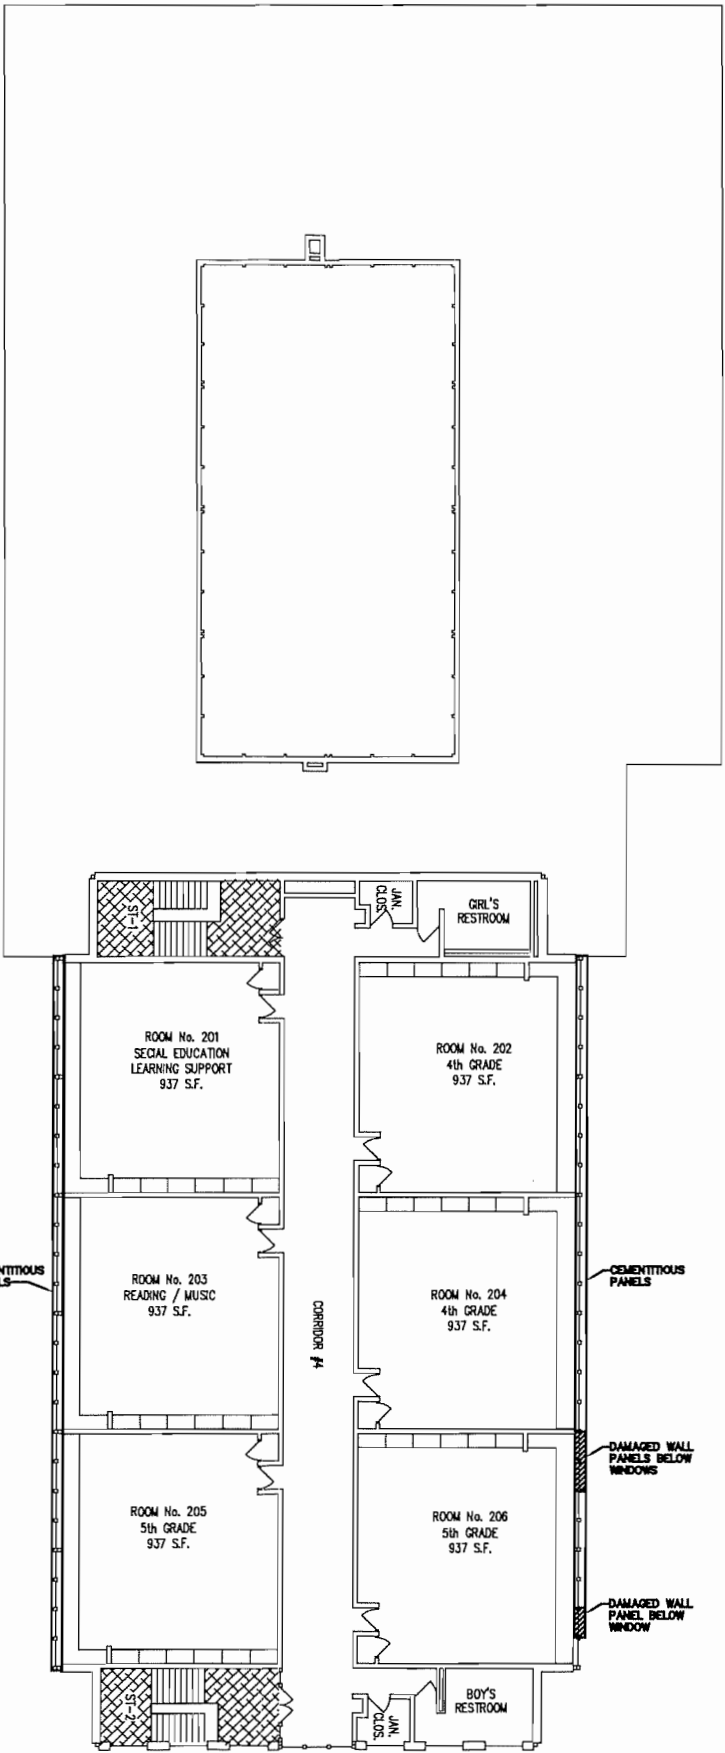
DRAWING No.:
**A
3**

KEY - MISCELLANEOUS ACM
ASSUMED ASBESTOS CONTAINING
MISCELLANEOUS MATERIALS:
1. CHALKBOARD MASTIC
2. DUCTWORK FLEX CONNECTIONS

KEY - MISCELLANEOUS ACM
9"x9" FLOOR TILE & MASTIC
12"x12" FLOOR TILE & MASTIC
ASSUMED ASBESTOS CONTAINING
MISCELLANEOUS MATERIALS:
1. CHALKBOARD MASTIC
2. DUCTWORK FLEX CONNECTIONS
EXTERIOR ASBESTOS CEMENT BOARD

KEY - MISCELLANEOUS ACM
9"x9" FLOOR TILE & MASTIC
EXTERIOR ASBESTOS CEMENT BOARD
ASSUMED ASBESTOS CONTAINING
MISCELLANEOUS MATERIALS:
1. CHALKBOARD MASTIC
2. DUCTWORK FLEX CONNECTIONS
